## Tensile Testing Report

**Report Number:** OSC-060

<b>Product name:</b>	<b>01.740.08</b>	<b>Testing equipment :</b>	<b>Tensile testing machine</b>
<b>Testing date:</b>	<b>02.08.21</b>	<b>Equipment load capacity:</b>	<b>300KN</b>

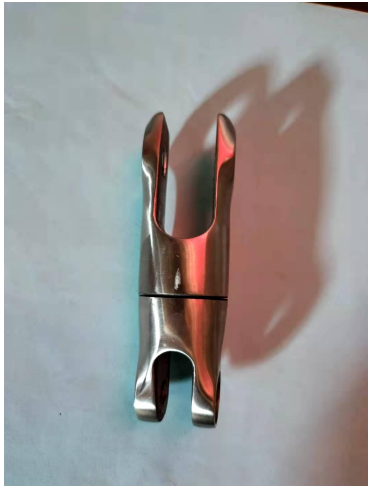
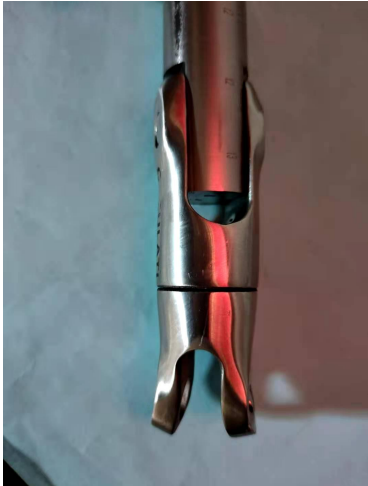
Sample photo before testing	Sample photo after testing

**According to the testing results, product 01.740.08 has the maximum breaking load capacity 35KN, screw of the product breaks, casting curve surface deforms.**
